USA-CERL INTERIM REPORT E-88/08  
July 1988

# Applying Energy Conservation Retrofits to Standard Army Buildings: Project Design and Initial Energy Data

by  
Eileen T. Westervelt  
G. Russ Northrup  
Edward O. Allen

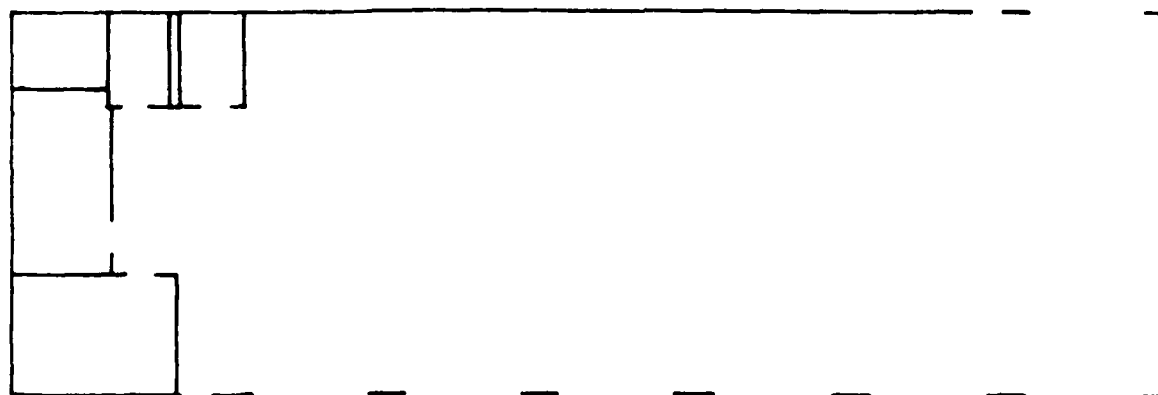
Figure 1. Floor plan: motor vehicle repair shop.

Figures 1 and 2 show a floor plan and an exterior view of the motor vehicle repair shop, respectively. The motor repair shop is a single-story rectangular structure with a floor area of 4800 sq ft and window area of 1278 sq ft. One end of the building has a fenced-in, secured area for an office and tools/parts storage. The rest of the building consists of high-bay vehicle work stations. Building walls are constructed of concrete blocks. Heating is provided by suspended steam unit heaters serviced by a steam boiler located in the mechanical room at the end of the building. Average baseline energy consumption for the motor repair shop was estimated at 2002 MBtu/yr. The retrofits proposed (see Table 2 and "Retrofit Details: Motor Vehicle Repair Shops") were expected to reduce this annual consumption by 35 percent.

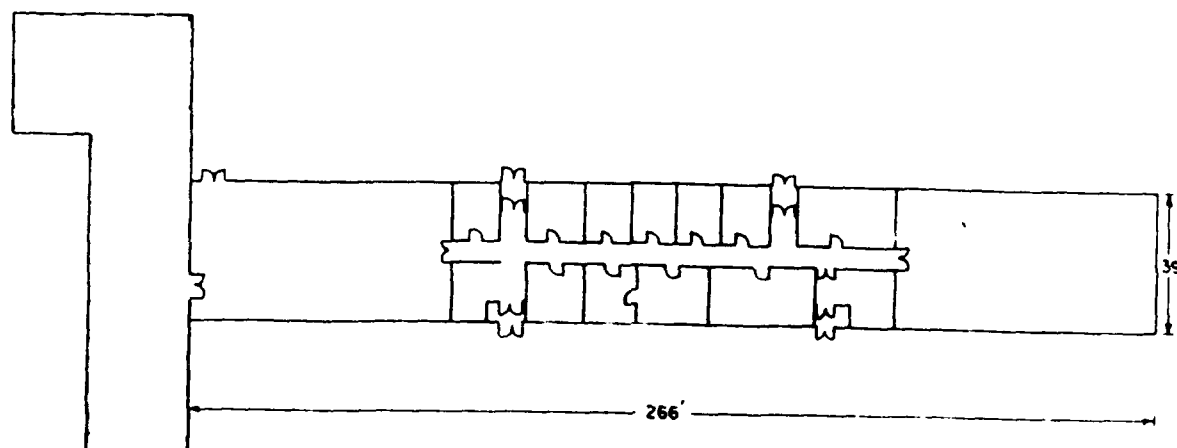
**Figure 3. Floor plan: L-shaped barracks.**

Figures 3 and 4 show a floor plan and an exterior view for the L-shaped (Type 64) barracks. The L-shaped barracks is a three-story building with an adjoining single-story mess hall area which has a total floor area of about 38,000 sq ft. There are 12,946 sq ft of concrete block exterior wall and 4965 sq ft of glass. Heating is provided by a hot water system which is serviced by two steam boilers located in the mechanical room of the building. Cooling is provided by a chilled water system which is serviced from a central plant. Average baseline energy consumption for the L-shaped barracks was estimated at 8346 million Btu/yr. The retrofits proposed (see Table 3 and "Retrofit Details: L-Shaped Barracks") were expected to produce a 41 percent reduction in this annual consumption.

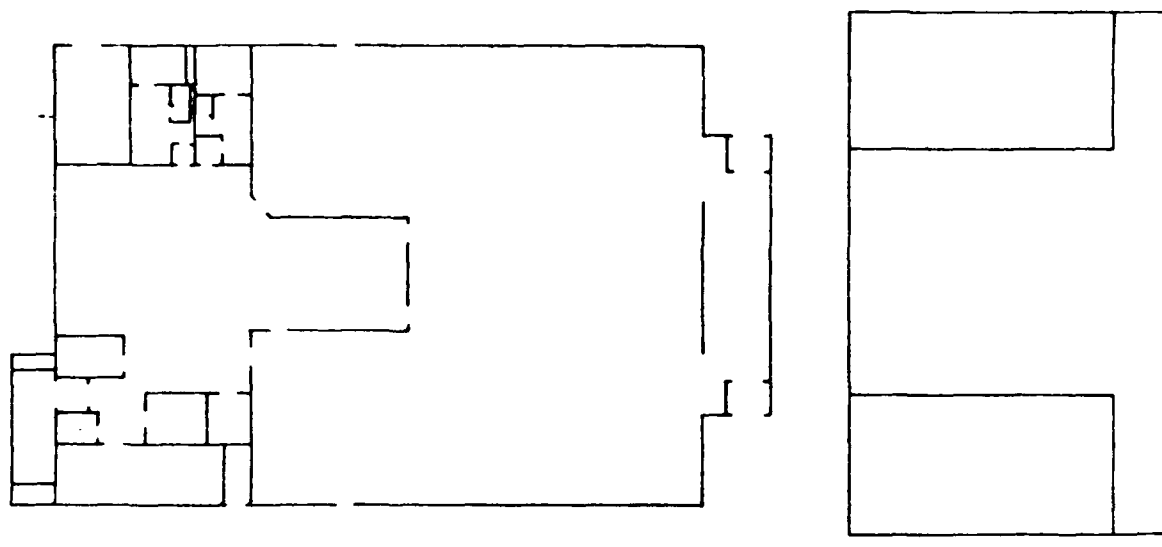
**Figure 6. Floor plan: dining hall.**

Figures 6 and 7 show a floor plan and an exterior view for the dining hall. The enlisted personnel mess hall is a one-story structure with an attic, kitchen, dining room, and a combined cloak room and entranceway. The total floor area is 10,620 sq ft. Walls are constructed of brick and concrete masonry units. The domestic hot water system and heating systems are serviced from a central plant. Average baseline energy consumption for the enlisted personnel mess hall was estimated at 5225 million Btu/yr. The retrofits proposed (see Table 4 and "Retrofit Details: Dining Hall") were expected to produce a 40 percent reduction in this annual consumption.

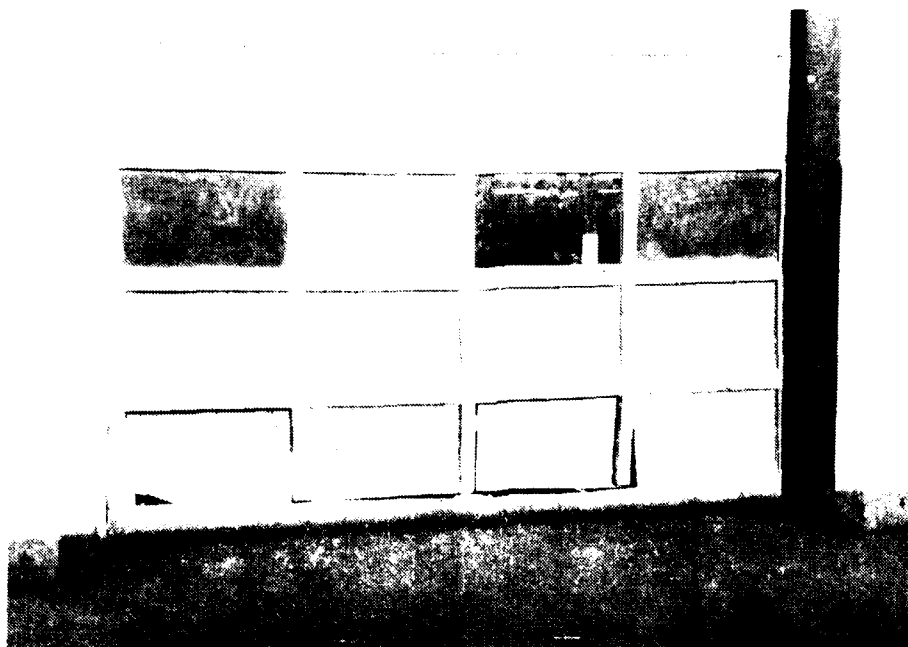
Figure 11. Old bay doors of motor shop.

In addition to the increased insulative value of the doors, the fact that they are new is a further benefit because all panels are intact (in contrast to the numerous holes and makeshift repairs in the existing doors) and the doors open and close easily, which makes the workers more likely to close them in cooler weather. The original plans had called for weather stripping around the doors rather than replacing them but the generally poor condition of the existing doors led to the replacement decision.

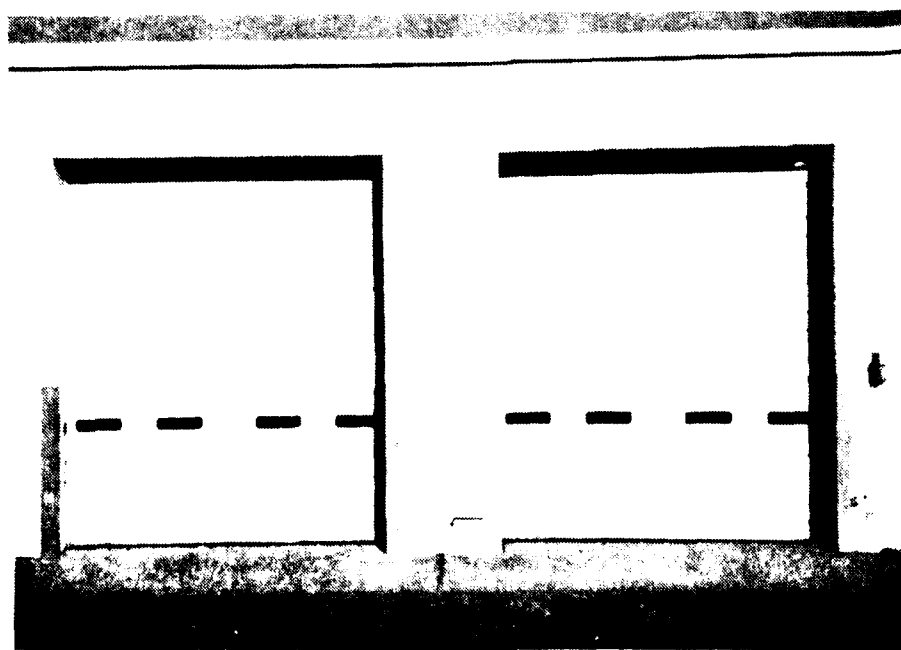
Figure 12. New bay doors of motor shop.

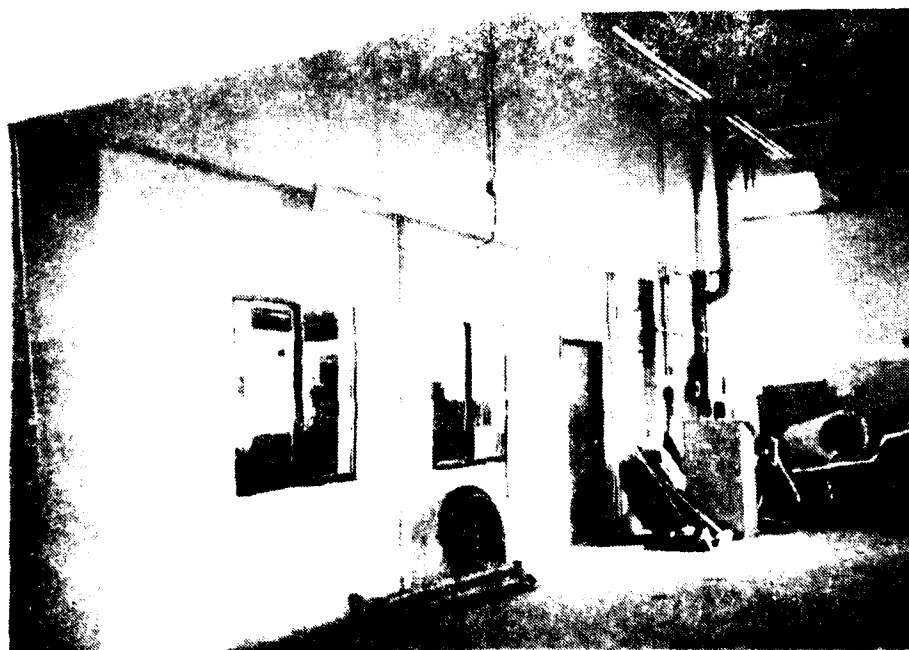
Figure 14. New wall partition between office and bay area of motor shop, replacing fence.

Office Area Partition. This retrofit has been met with great enthusiasm by the occupants who can now work at their desks in warmer conditions than can be maintained in the bay area. This also provides bay area workers with a warm refuge after extended work periods. These comfort considerations have prompted the occupants of nearby shops to employ this or similar modifications to their buildings, even though the energy savings have not been verified.

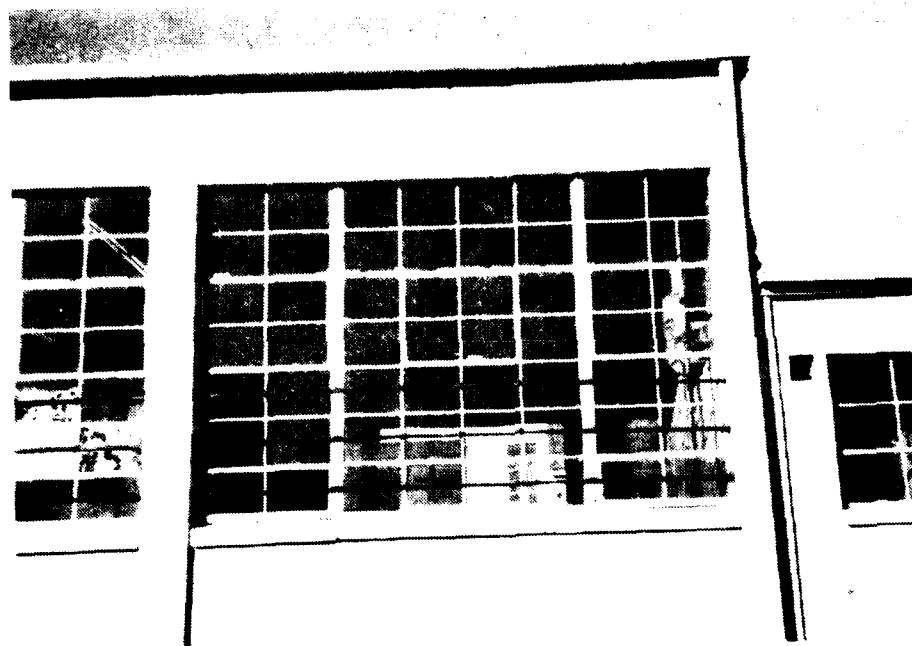
Figure 15. Old windows of motor shop.

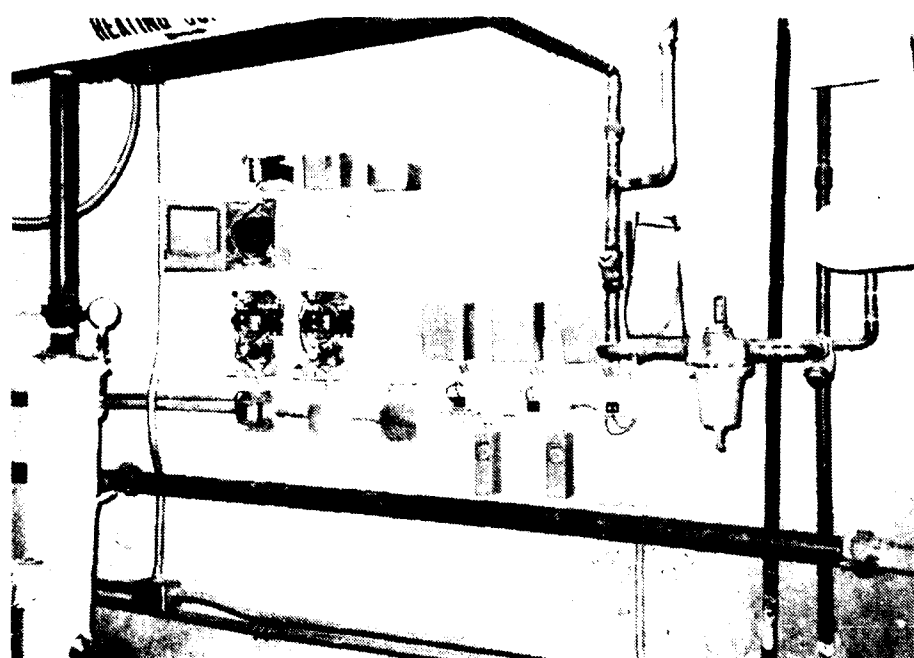
Figure 22. Old electric controllers of L-shaped barracks.

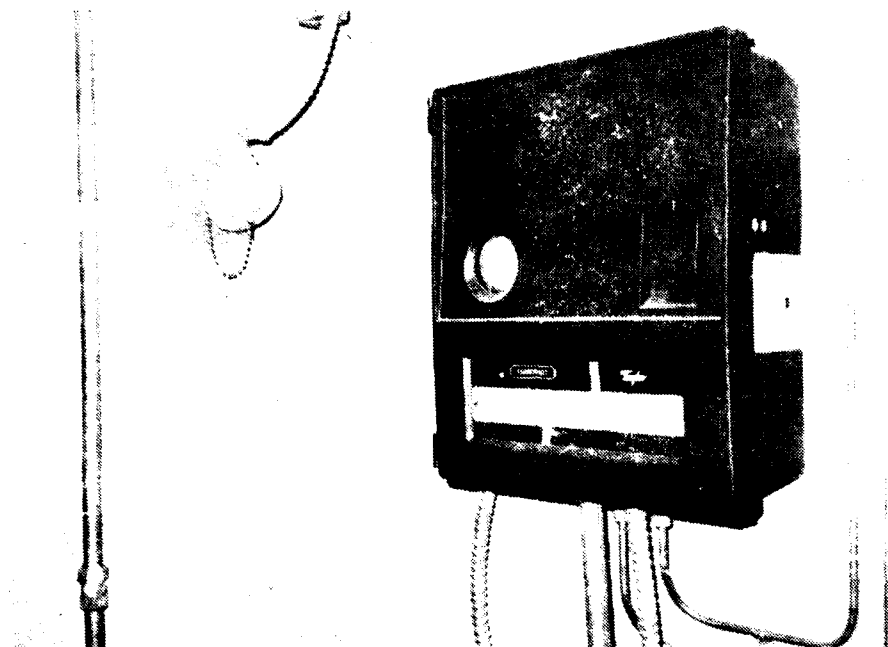
**Figure 26.** New pneumatic reset controllers (with outside air RTD) of dining hall.

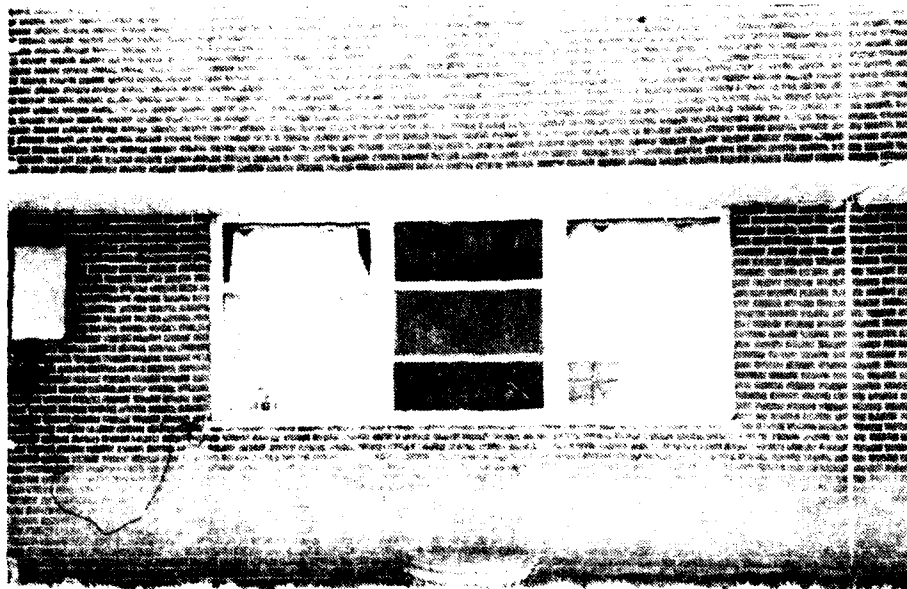
Figure 27. Old windows of rolling pin barracks.

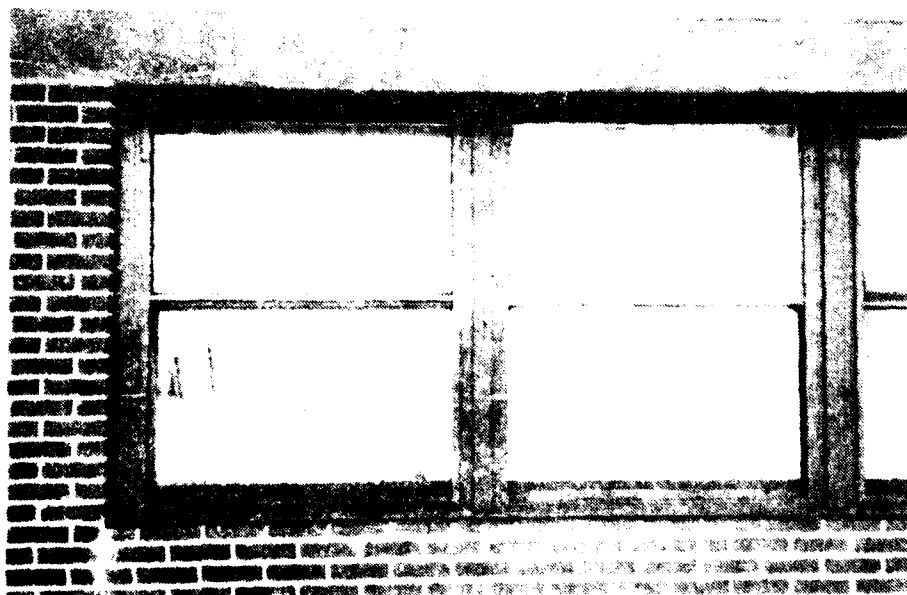
Figure 28. New windows of rolling pin barracks.

New window units	All of the existing 286 window units were replaced with Alenco double-glazed, thermal-type window units.
Heating system controller	A new Taylor heating system controller was installed to more precisely control the temperature of the circulating hot water according to the outside air temperature. The water temperature is adjusted (linearly) between 200 and 140 °F as the outside air varies from 0 to 65 °F. The control system was replaced due to its technological and chronological age.
Low leakage dampers for intake air	Two 3 ft by 9 ft existing intake air dampers were replaced with Barber Coleman low leakage dampers.

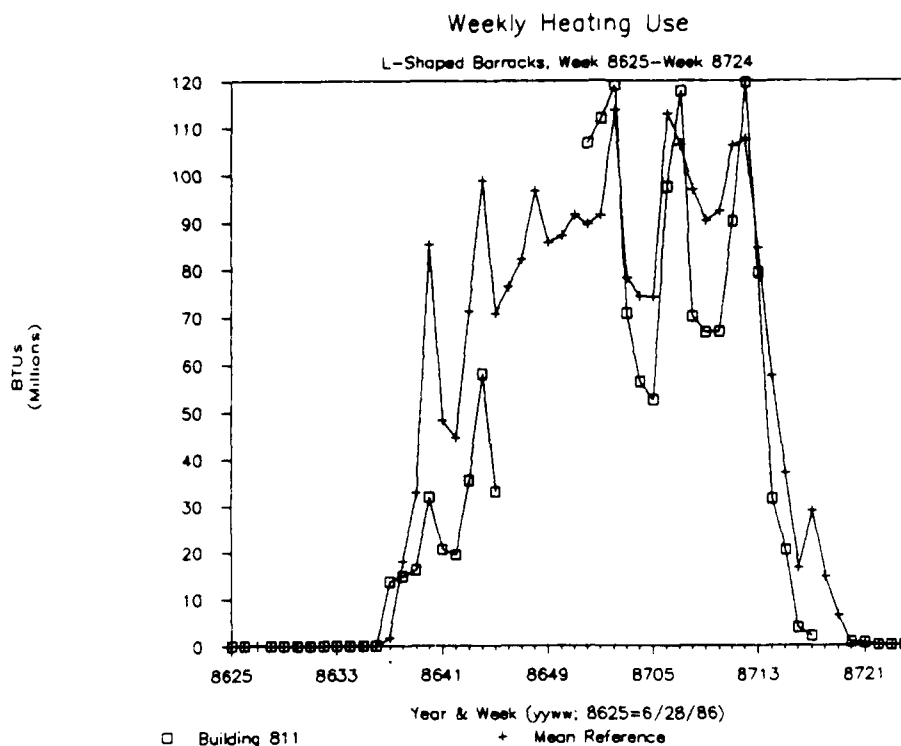
**Figure 34. Weekly heating use of L-shaped barracks, week 8625 - week 8724.**

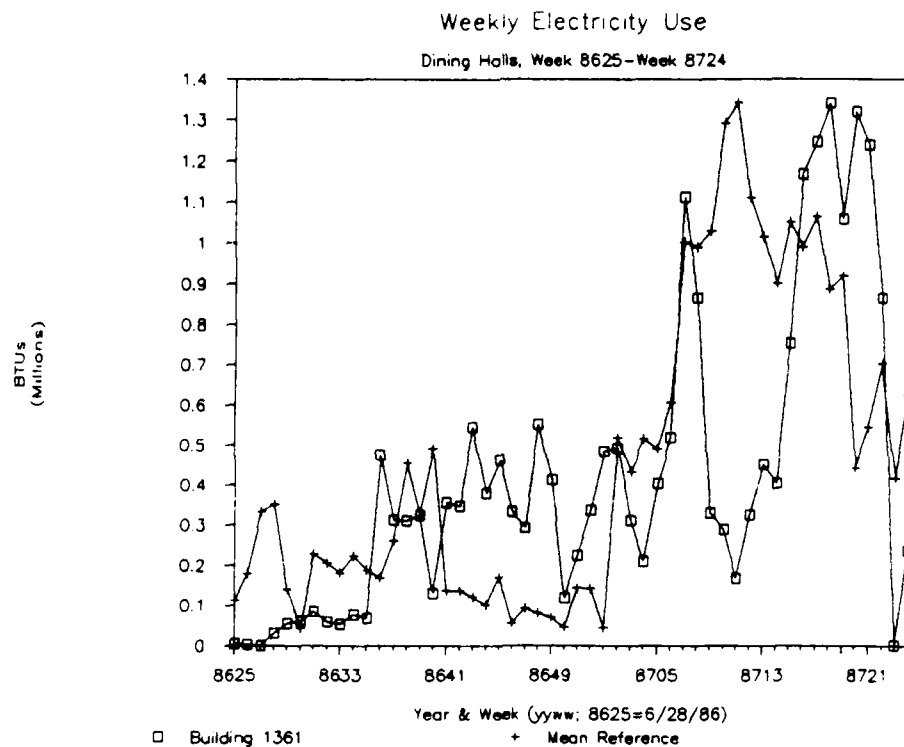
**Figure 35. Weekly electricity use of dining hall week 8625 - week 8724.**

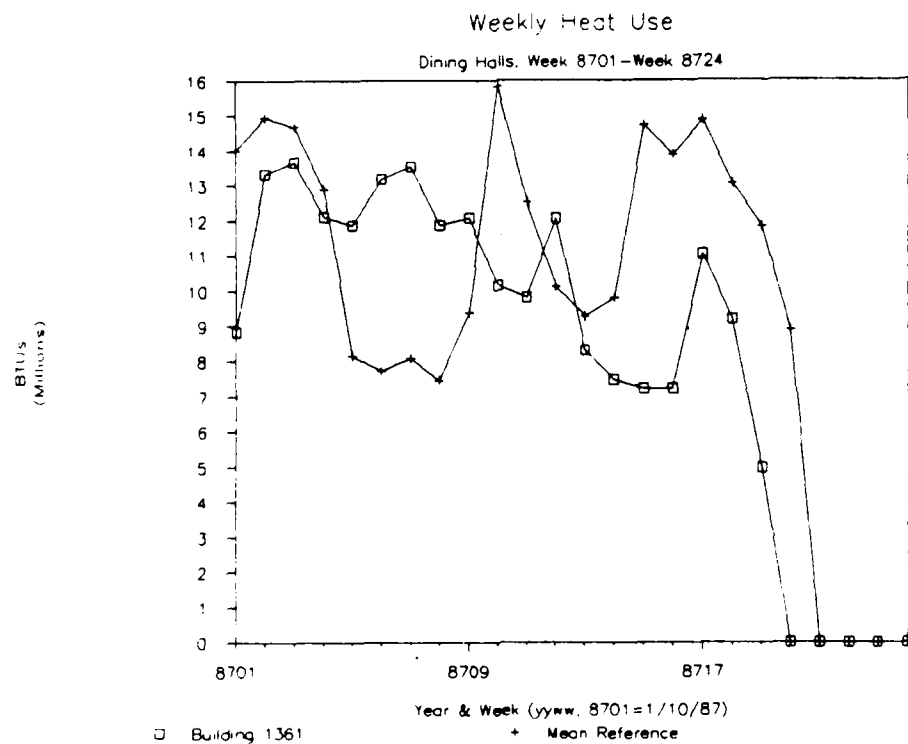
**Figure 36. Weekly heating use of dining hall, week 8701 - week 8724.**

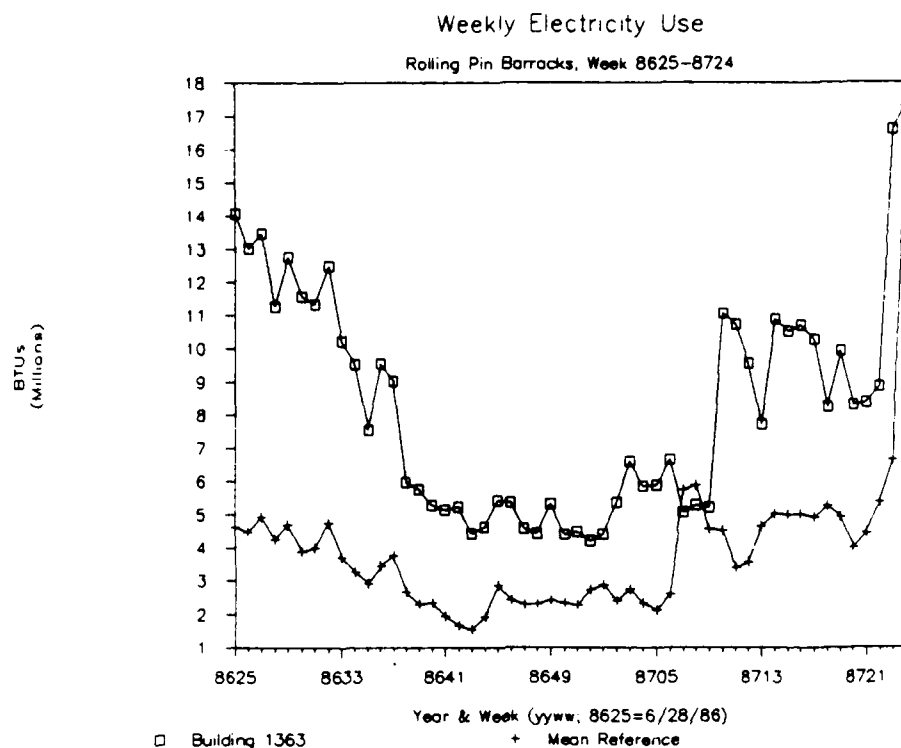
**Figure 37. Weekly electricity use of rolling pin barracks, week 8625 - week 8724.**

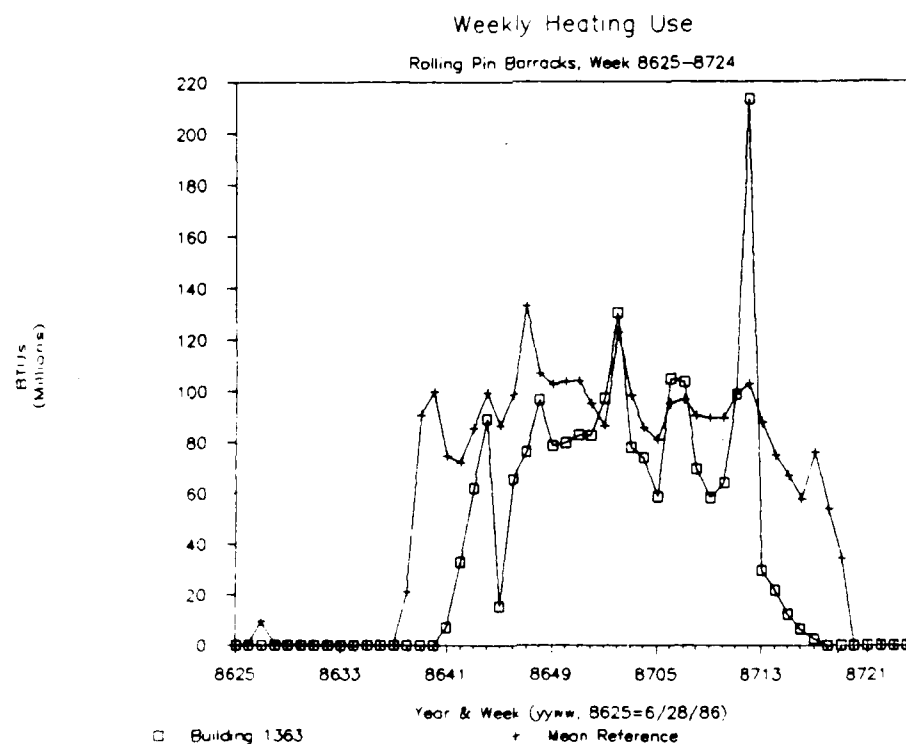
**Figure 38. Weekly heating use of rolling pin barracks, week 8625 - week 8724.**

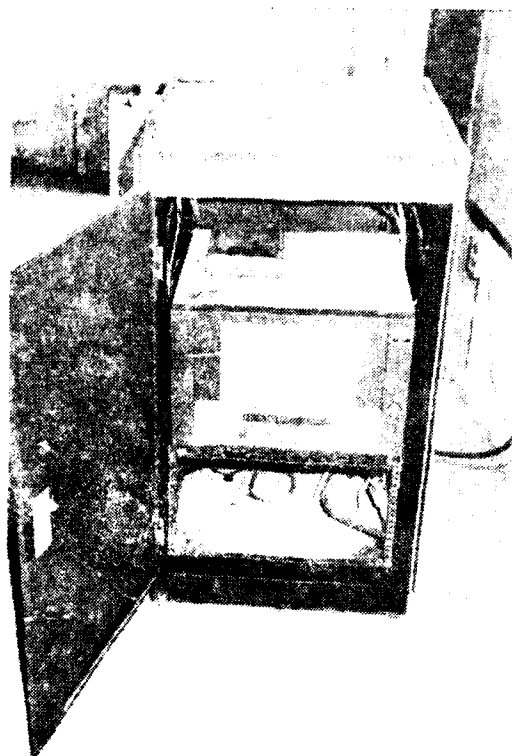
Figure A1. Front view of datalogger in cabinet.

**Cabinets.** A locked, steel-rack cabinet houses each Autograph (Figures A1 and A2). The cabinet's sliders hold the Autograph and modem off the floor and out of danger from mechanical room flooding. The doors of the cabinet conceal the front panel keyboard and fluorescent display from would-be investigators. The cabinet also serves as a mounting surface for telephone jacks and cable connections and as storage space for extra paper and a few tools.

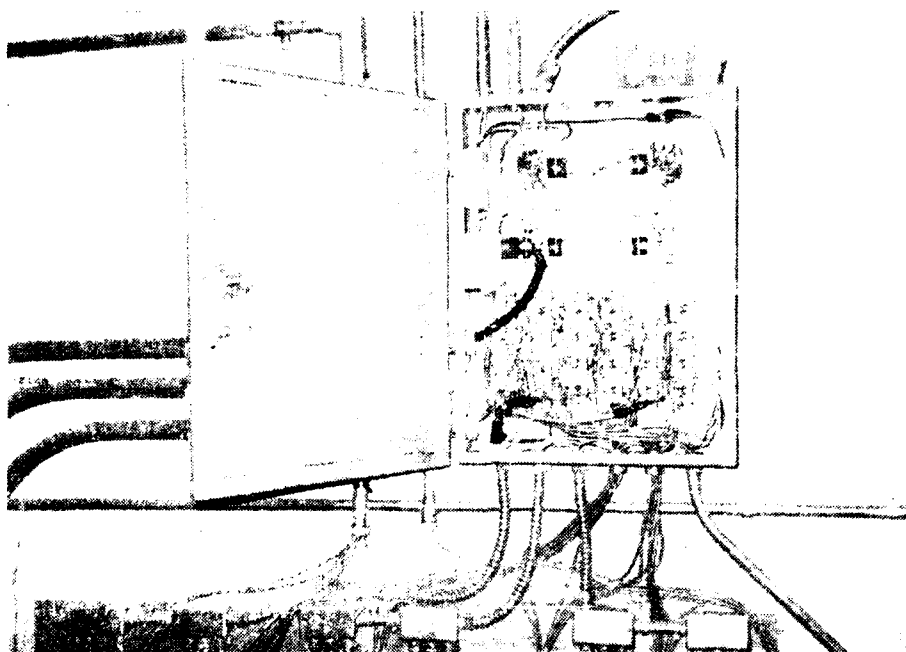
Figure A3. Wall panel at L-shaped barracks.

**Cabling.** Signal cables from the various instruments are brought to terminal blocks in a wall panel (Figure A3). Wiring from the wall panel is then brought to the cabinet containing the Autograph. Inside the cabinet the signal cable is terminated with a DB-25 connector whose mating connector is attached to a short "pigtail" run of signal cable from the Autograph input cards (Figure A4). This cabling scheme between instrument and Autograph provides two benefits. First, it simplifies the thorough checkout for accuracy and safety of instrument signals prior to connecting them to the Autograph.

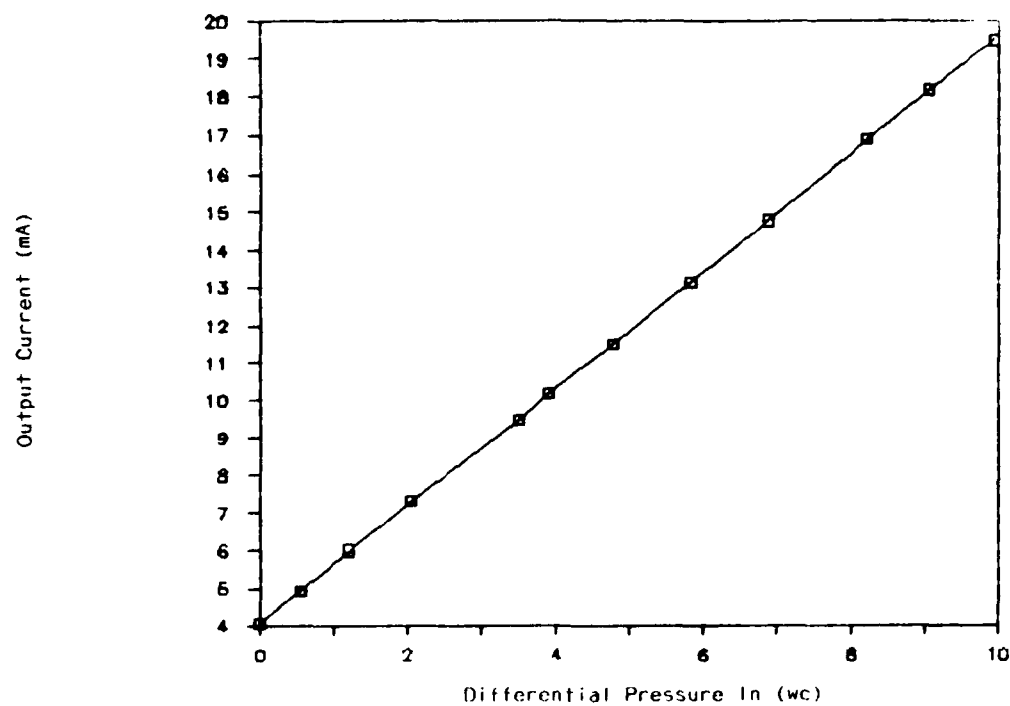
Figure A9. PT linearity for unit #1.

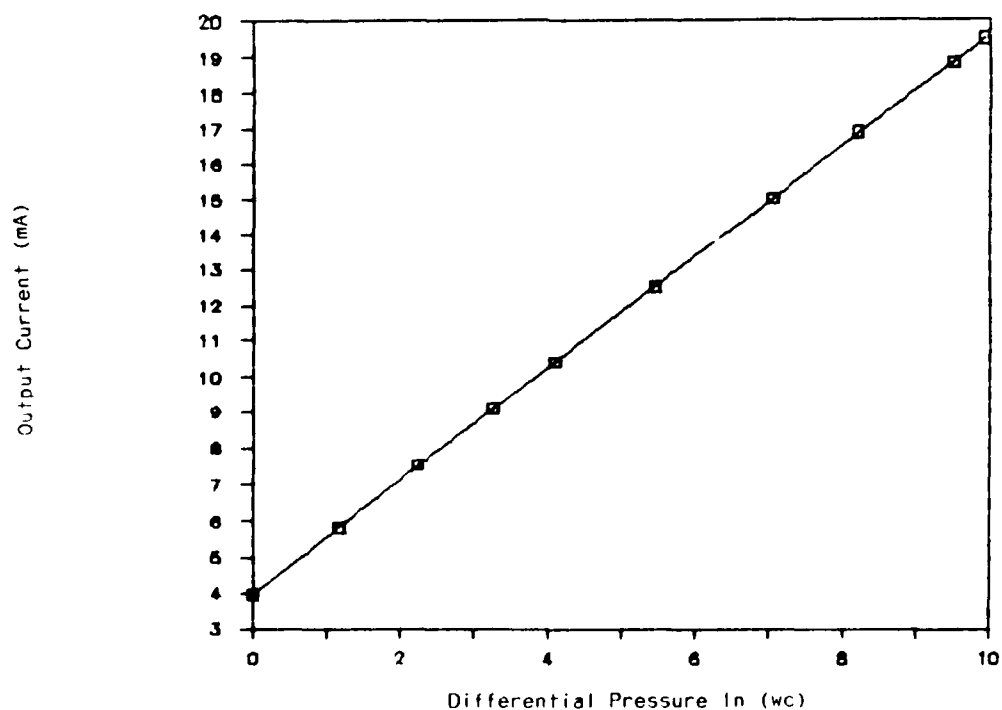
Figure A10. PT linearity for unit #2.

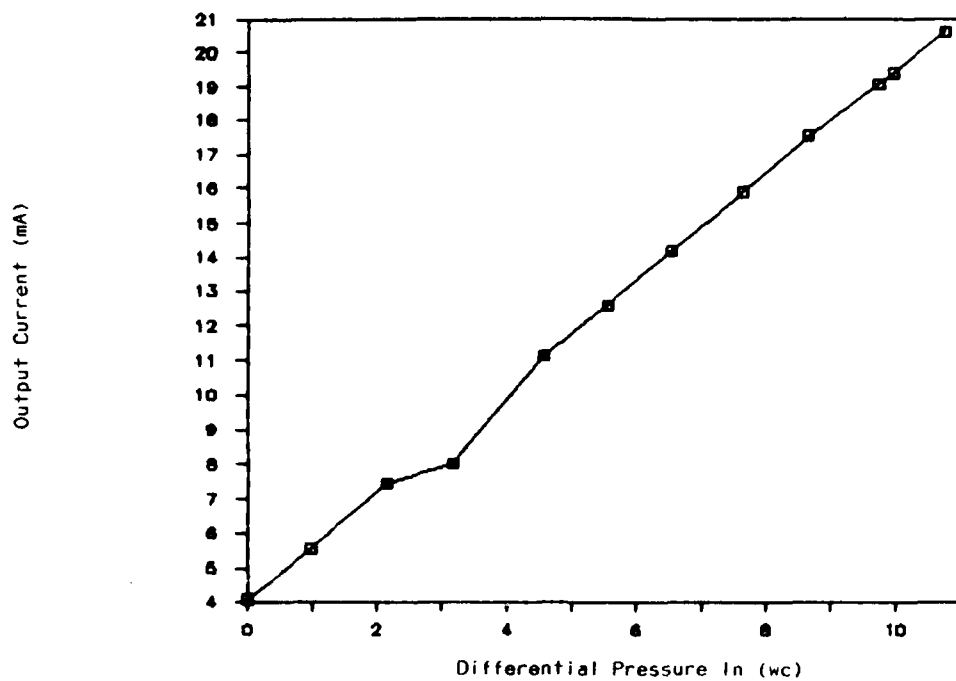
Figure A11. PT linearity for unit #3.

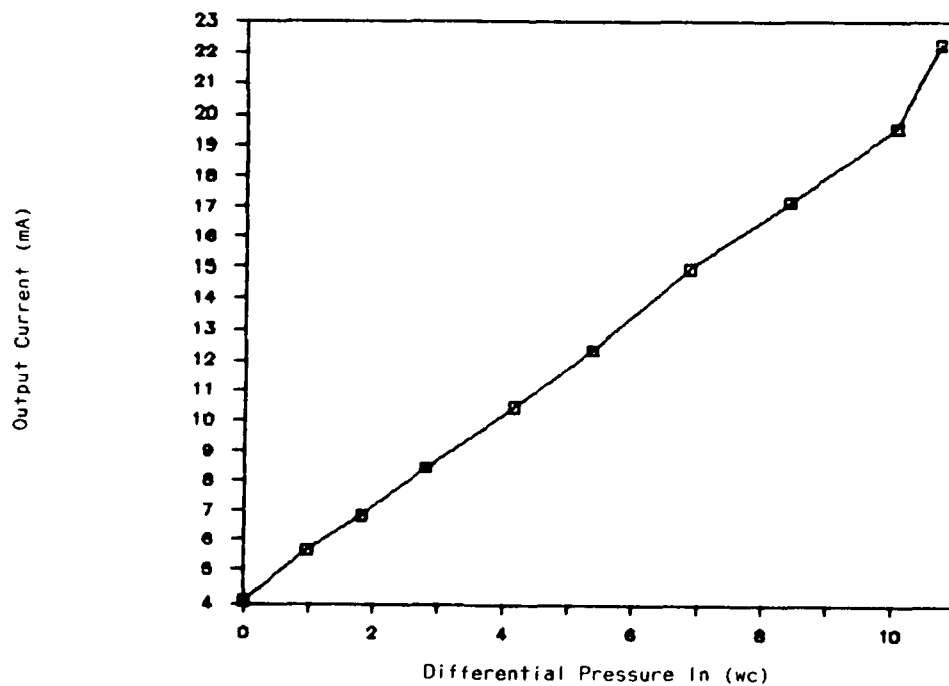
Figure A12. PT linearity for unit #4.
